**Fuji Electric Exhaust Gas Cleaning System (EGCS)**  
**Bubbles or Films Generated Near the SOx Scrubber Outlet while Berthing** (FESN-2119  
Follow-up Report)

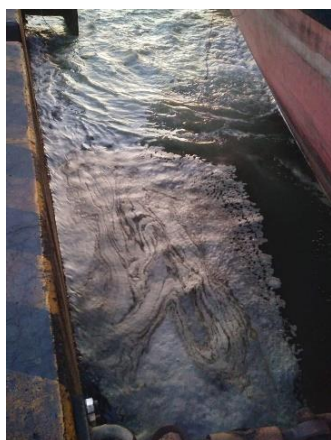
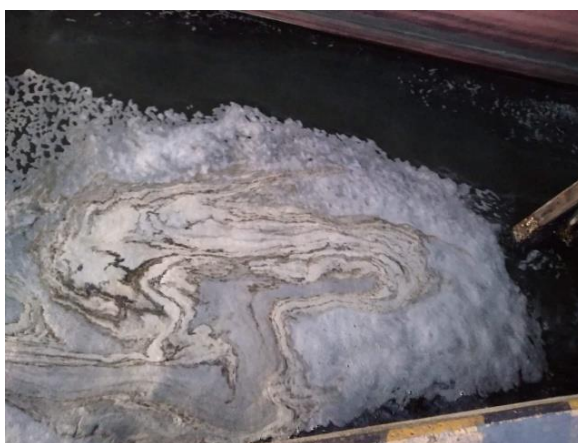
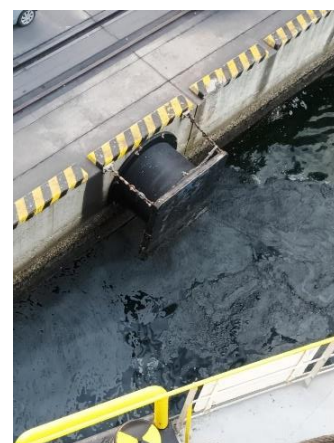
We occasionally receive reports that when a ship equipped with our EGCS is berthed with the EGCS running, a bubble-like or filmy substance appears on the sea surface near the SOx scrubber outlet. With regard to this issue, we have prepared the following report.

The system detects abnormalities in wastewater components and issues an alarm when the three water qualities (pH, turbidity, PAH) exceed the criteria in the guidelines (Chapter 10 “Discharge Water”). Even when bubbles or films appeared on the sea surface thus far, the discharge water quality met the criteria.
