December 2008
Fuji Electric Systems Co., Ltd.
Controller Div.
Automation & Solution Business
Headquarters

MICREX-SX Series Notice of SPB Functional Expansion

We would like to thank you for your continued patronage of Fuji Programmable Controllers.
Please be informed that Fuji Electric Systems has expanded a function in the MICREX-SX-series SPB (SX mode) with a firmware upgrade.

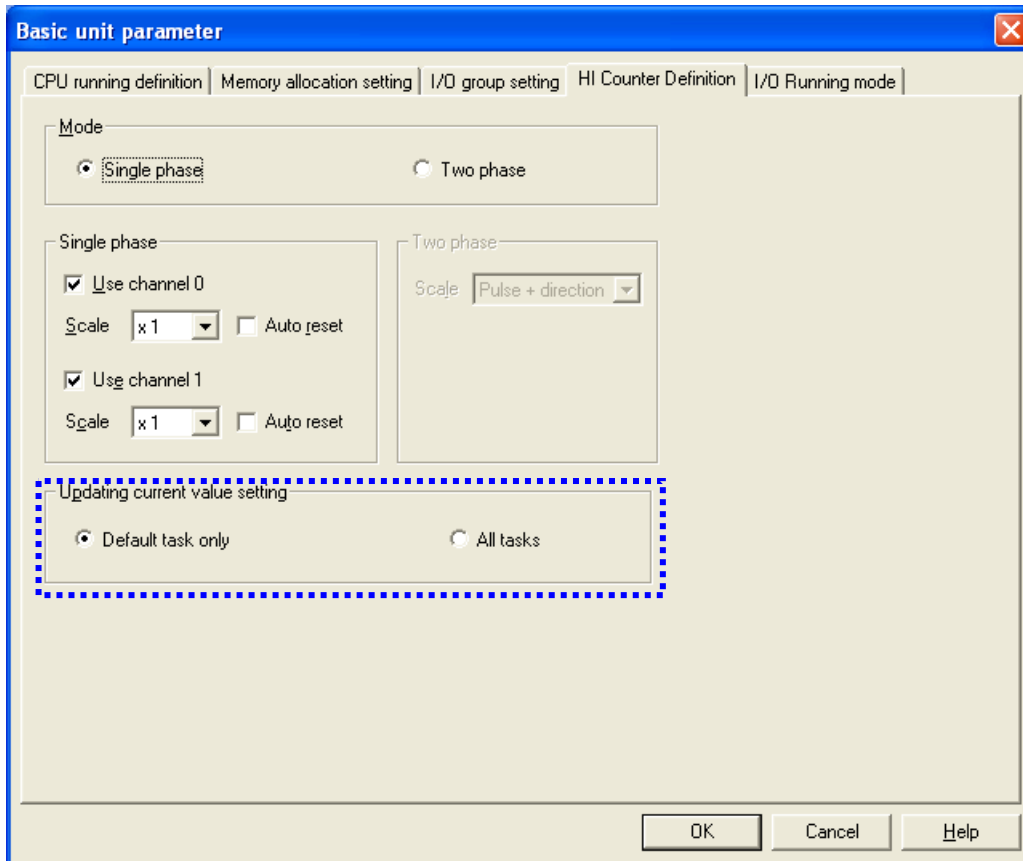
With the new version, it is possible to update the current value of a high-speed counter in synchronization with a scheduled task or event task.

Conventionally, the current value of a high-speed counter was updated in synchronization with the execution of the default tasks, which involved a maximum execution time delay equivalent to the execution cycle of the default tasks.

With this expansion, the current value can be updated in synchronization with the execution of an individual task. Therefore, the execution time delay of the current value read in each task will be limited to a maximum period of the task execution time.

The updating of current value setting is by default set to *Default task only* to maintain compatibility with the previous version of the Board Controller.
